# *Acta Beregsasiensis*

2010  
IX. évfolyam, 1. kötet  
Том IX, № 1  
Volume IX, № 1

## **The effect of human work on the environment in the delta of river Borzsa, the right-side branch of the Tisza**

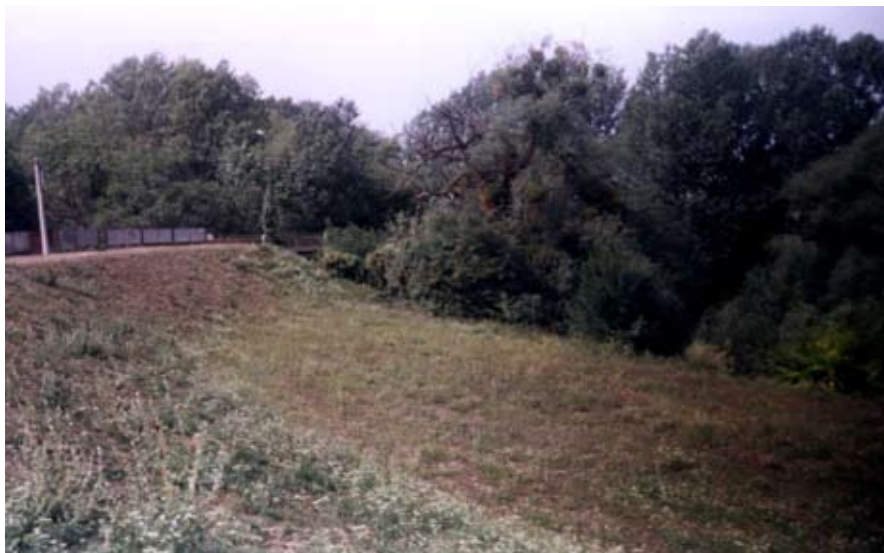
flat and even, of plainy character, which is rarely scattered with differing hills. The relief slightly slopes to the south, what is shown also by the course of Borzsa. The environs of the village vary between 110–120 metres above sea level. The formation of the territory may be thanked to the deposition of sediments of the Tisza and Borzsa, which caused the territory's banking up with accumulative layers. The levels of this banking up could have been seen during the latest floods, when in some places of the flood area of the mentioned rivers there developed a sediment layer of 15–20 centimetres (Fig. 2).

**Fig. 2. Deposit accumulation along the Borzsa left bank** (Izsák T., 2003)

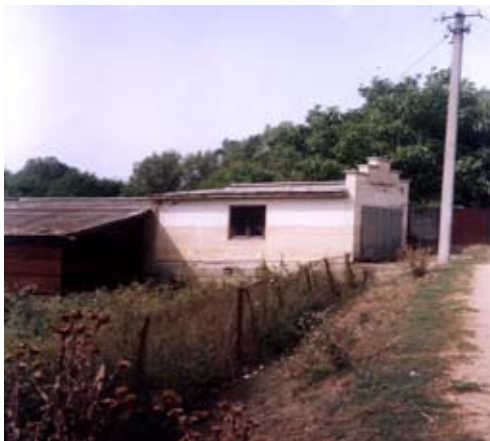
During the November 1998 floods, already more than 200 homes collapsed along the left side of the Borzsa River, concentrating in the Palaj part of the village. Three years later, during the March 2001 floods, 30 more homes collapsed. During these floods, for a couple of days, Palaj became the “Venice” of Transcarpathia. The water level exceeded the 3 meters height at certain places (*Fig. 3*). The question arose: is nature the only culprit of these floods or is the industrial activity of the human kind also responsible.

**Fig. 3. Level of flood on the wall of the building in March 2001**

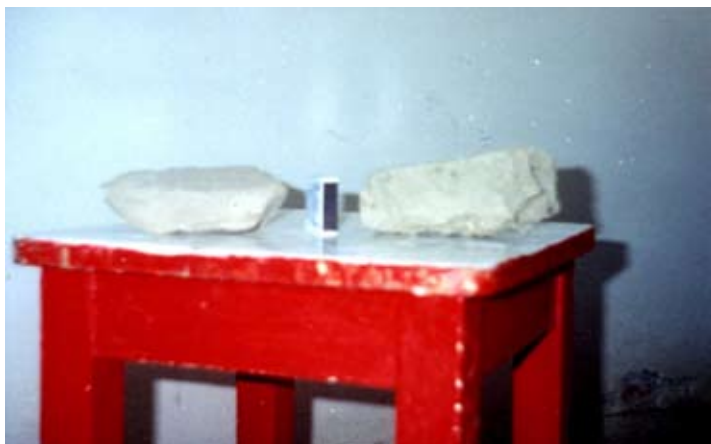
At the time of these two major floods, one kilometer away upstream from the firth of Borzsa, approximately at the same locations mud-samples were taken from the surface of the 5-degree slopes. The 1998 sample was 4,2 cm thick, and the 2001 mud-deposit thickness reached the 5,7 cm (*Fig. 4*).

**Fig. 4. Mud-samples of the wave-area** (IZSAK T., 2003)

Research results of the firth-area show, that the deposited and leftover mud thickness is in direct proportion to the decrease of the landscape's slope-degree. Thus, the mud-layer was the thickest within the horizontal areas, while on the slopes of the dams and riverbank it was much thinner or was completely washed away. The only exceptions were the closed basin-like dents, where the deposit layer reached the 10-15 cm range. At the firth area of the Borzsa river the average wave-area fill-up process depends on the timeframe of flood clearing and reaches the 5–7 cm range per flood. This may have caused a 85–119 cm fill-up since finishing the river regulations – since the end of the 1840's – when the dam-series were built along the left-side of the Borzsa river. If we add to these deposit-accumulations occurring at least once in a year – spring – flood deposit as well, than within one hundred years the wave-area fill-up (among ideal conditions) can reach 5 meters' height at certain locations. In the past thirty years after the river regulations, as a result of the wave-area fill-up process, the residual ponds, river basins, smaller ponds — “cubics”, which were created by increasing the height of the dams –and the associated flora and fauna have almost completely vanished.

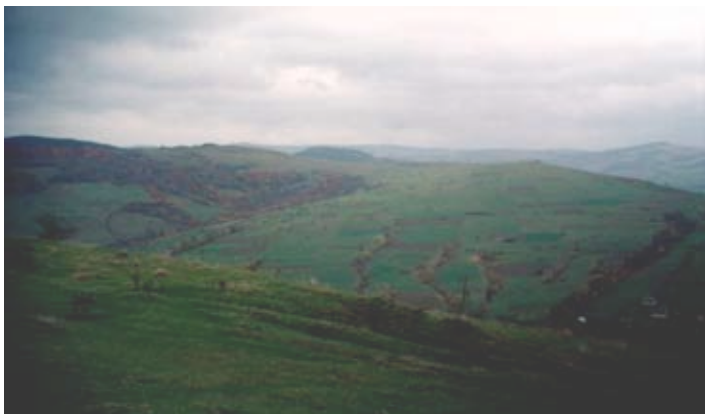
**Fig. 5. Erosion processes in the area of Ökörmező** (IZSÁK T., 2002)

Trees have soil retaining and water evaporating ability. By the decrease in forestry the degree of soil erosion increased. During the 20<sup>th</sup> century, in Transcarpathia 15 (1913, 1927, 1933, 1941, 1947, 1948, 1955, 1957, 1968, 1970, 1980, 1992, 1993, 1995, 1998) major floods occurred on the Tisza and its tributaries (REPORT, 2002). At the firth area of the tributaries, mainly on the wave-areas, as a result of deforestation the accumulation of mud depositing and the speed of the wave-area fill-up increased significantly. Live-stock-farming on the poloninas, territory above tree-level, and grazing on the flood-areas contributed to the increase of soil erosion and water-downflow (Fig. 5.). The rainfall on the Upper-Tisza drainage-area goes to the river in 2–3 hours from the surface, which drastically increases the level of the wave-area (REPORT, 2002). The speed of the river during flood times can reach 1.2-1.6 m/s, which means, that the developing larger flood-waves on the Upper-Tisza area can even reach the town of Vári (150 km) within 24 hours.

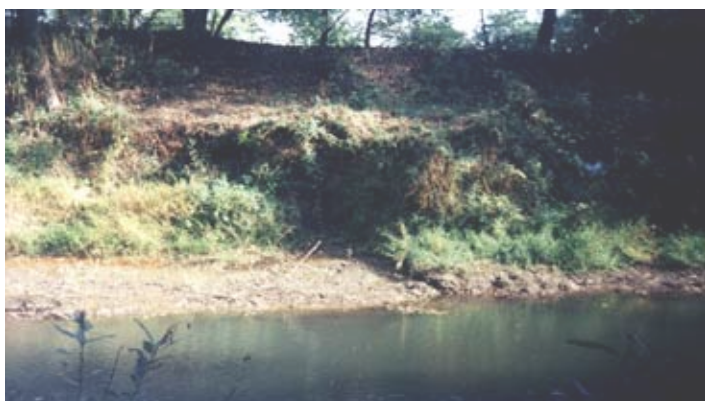
Due to the often-occurring water-level fluctuation in the firth-area of Borzsa the bank-erosion increases. In the past century, in 1960's this process was delayed with the development of stone-defense line along the right bank of the river Borzsa. On the other hand, the left side bank of the river remained unprotected, therefore the erosion and degradation of riverbank can be observed (*Fig. 6.*). Due to our observations the degree of the bank-erosion can reach 20–30 cm a year. The developing deposit will be unloaded somewhere along the basin of the river Tisza. This process could be eliminated by plantation on the riverbank and forestation on the wave-area. However, forests in the flood-area have been thinned out lately, which caused the increase of bank-erosion.

**Fig. 6. Erosion at the left bank of the river Borzsa** (IZSÁK T., 2003).

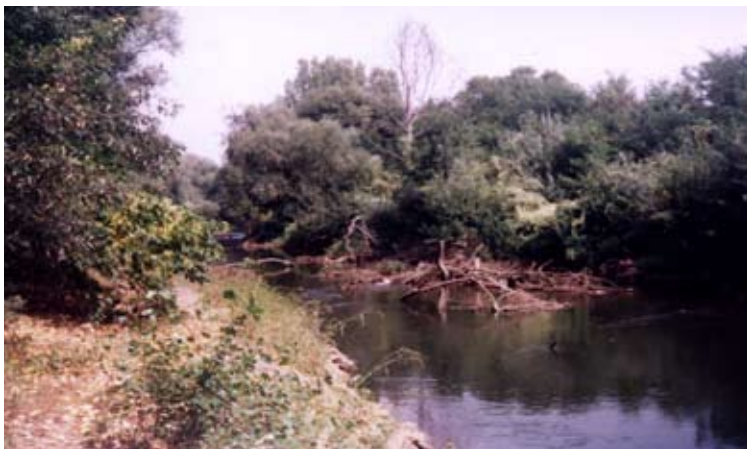
On the riverbank, the water-flow is under-washing the trees causing them to fall into the river. These trees and all the cut out and unremoved branches pile-up and slow down the water-flow and the faster passing down of floods (Fig. 7).

**Fig. 7. Piled-up branches in the river Borzsa** (Izsák T., 2003)
